by Navid Nastar, PhD PE

# Earthquake Damage

## *Who is to blame?*

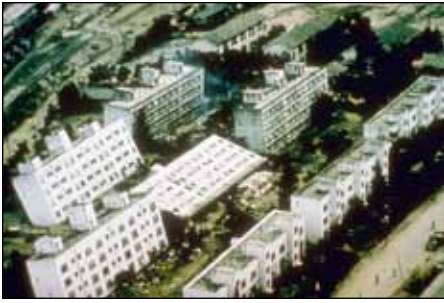
Figure 1. Damage due to soil liquefaction in apartment buildings in Niigata, Japan, Niigata Earthquake (magnitude 7.5), June 16, 1964. Liquefaction is a phenomenon that happens when the strength of saturated soil is reduced by the earthquake's sudden movements and as a result the soil behaves like a heavy liquid. Photo courtesy of NGDC ([www.ngdc.noaa.gov](http://www.ngdc.noaa.gov)).

In addition to the items described above, aging and deterioration of structural elements can significantly contribute to the earthquake damage in buildings. *Figures 1 through 8* depict some examples of structural damage during historic earthquakes.

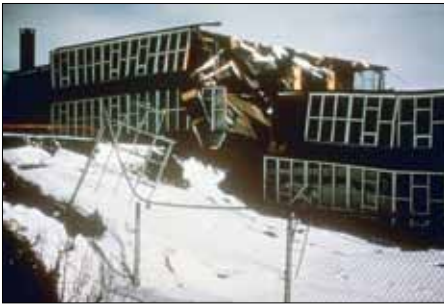
Figure 2. Damage due to ground deformation in a school in Anchorage, Alaska Earthquake (magnitude 9.2), March 28, 1964. Photo courtesy of NGDC ([www.ngdc.noaa.gov](http://www.ngdc.noaa.gov)).

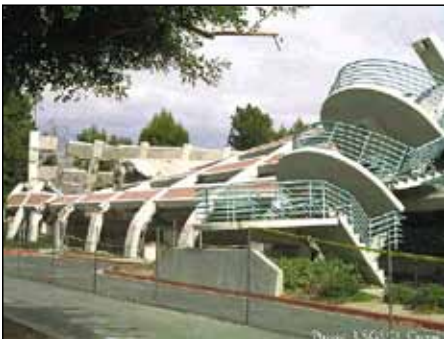
Figure 3. Severe damage in a concrete parking structure, California State University, Northridge, Northridge Earthquake (magnitude 6.7), January 17, 1994. Photo courtesy of USGS ([www.usgs.gov](http://www.usgs.gov)).

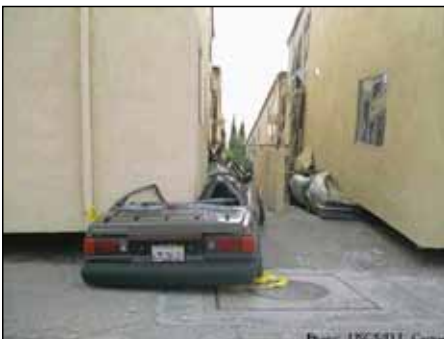
Figure 4. Soft story damage in a building during Northridge Earthquake (magnitude 6.7), January 17, 1994. Soft story is typically the result of one the stories being laterally softer than the others due to large window and door openings or parking garages. Photo courtesy of USGS ([www.usgs.gov](http://www.usgs.gov)).

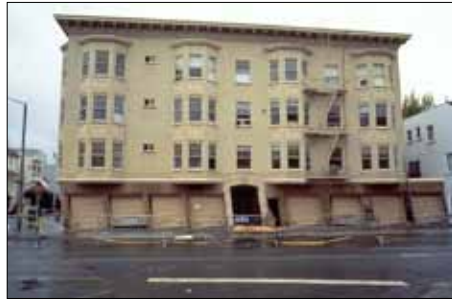
Figure 5. Soft story damage in a building during Loma Prieta Earthquake (magnitude 6.9), October 17, 1989. Photo courtesy of USGS ([www.usgs.gov](http://www.usgs.gov)).

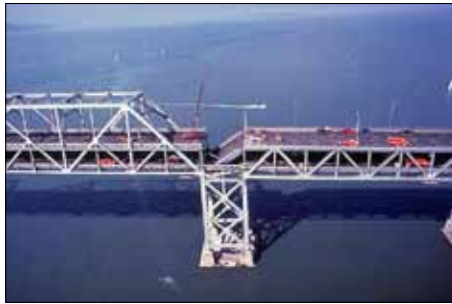
Figure 6. San Francisco Bay Bridge 2nd level collapse, Loma Prieta Earthquake (magnitude 6.9), October 17, 1989. Photo courtesy of USGS ([www.usgs.gov](http://www.usgs.gov)).

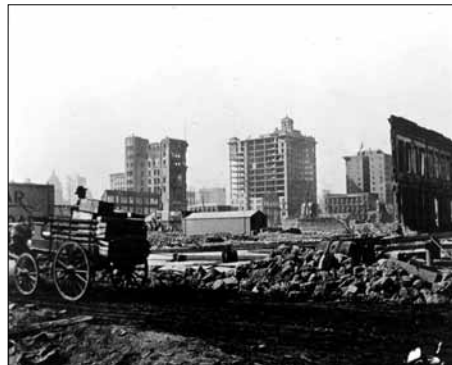
Figure 7. Massive earthquake and fire damage in San Francisco, San Francisco Earthquake (magnitude 7.8), April 18, 1906. The fire resulting from the earthquake was a major contributor to the losses. Photo courtesy of USGS ([www.usgs.gov](http://www.usgs.gov)).

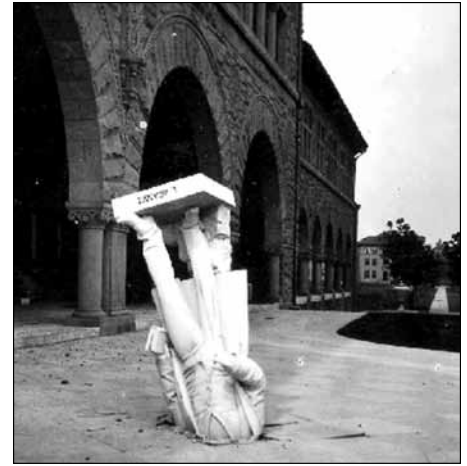
Figure 8. The Agassiz statue, Stanford University, San Francisco Earthquake (magnitude 7.8), April 18, 1906. Photo courtesy of USGS ([www.usgs.gov](http://www.usgs.gov)).

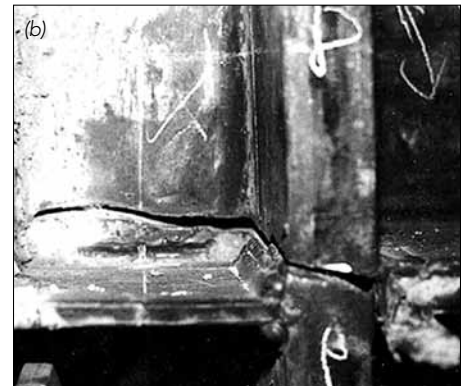
Figure 9: (a) Typical fracture initiation in Pre-Northridge beam-to-column connections in steel buildings; (b) Propagation of crack into the column flange and web. Photos courtesy of FEMA (FEMA-267: SAC Interim Guidelines and FEMA-350: Recommended Seismic Design Criteria for New Steel Moment-Frame Buildings, June 2000).

Following the earthquake, there was widespread damage to the beam-to-column connections used in many steel buildings. These connections, now known as Pre-Northridge connections, are part of the LFRS of steel buildings, and their failure raised major questions regarding the behavior of this commonly used connection. *Figure 9* illustrates the typical damage observed in the beam-to-column connections of steel buildings following the Northridge Earthquake. Before the Northridge earthquake, steel buildings were believed to have good seismic performance because their ductility and flexibility allowed them to survive large ground motions. After the Northridge Earthquake and the Kobe, Japan earthquake in 1995, the observed damage in numerous steel structures surprised many owners and building experts.

The study found that local connection defects, including the flaws associated with field welding of beam-to-column joints using backing bars, were the major contributors to the observed damage. Based on these findings, the use of traditional Pre-Northridge connections became prohibited in new construction, and modified methods of rigid beam-to-column connection were born. Through testing, these connections demonstrated improved seismic behavior compared to Pre-Northridge connections. Dogbone or Reduced Beam Section (RBS), SitePlate, and SlottedWeb are a few examples of this group of enhanced beam-to-column connections, also referred to as Post-Northridge connections.
